Our File Ref.: 160845

**Subject: Slope Stability Analysis
 Menard East Subdivision
 Embrun, Ontario**

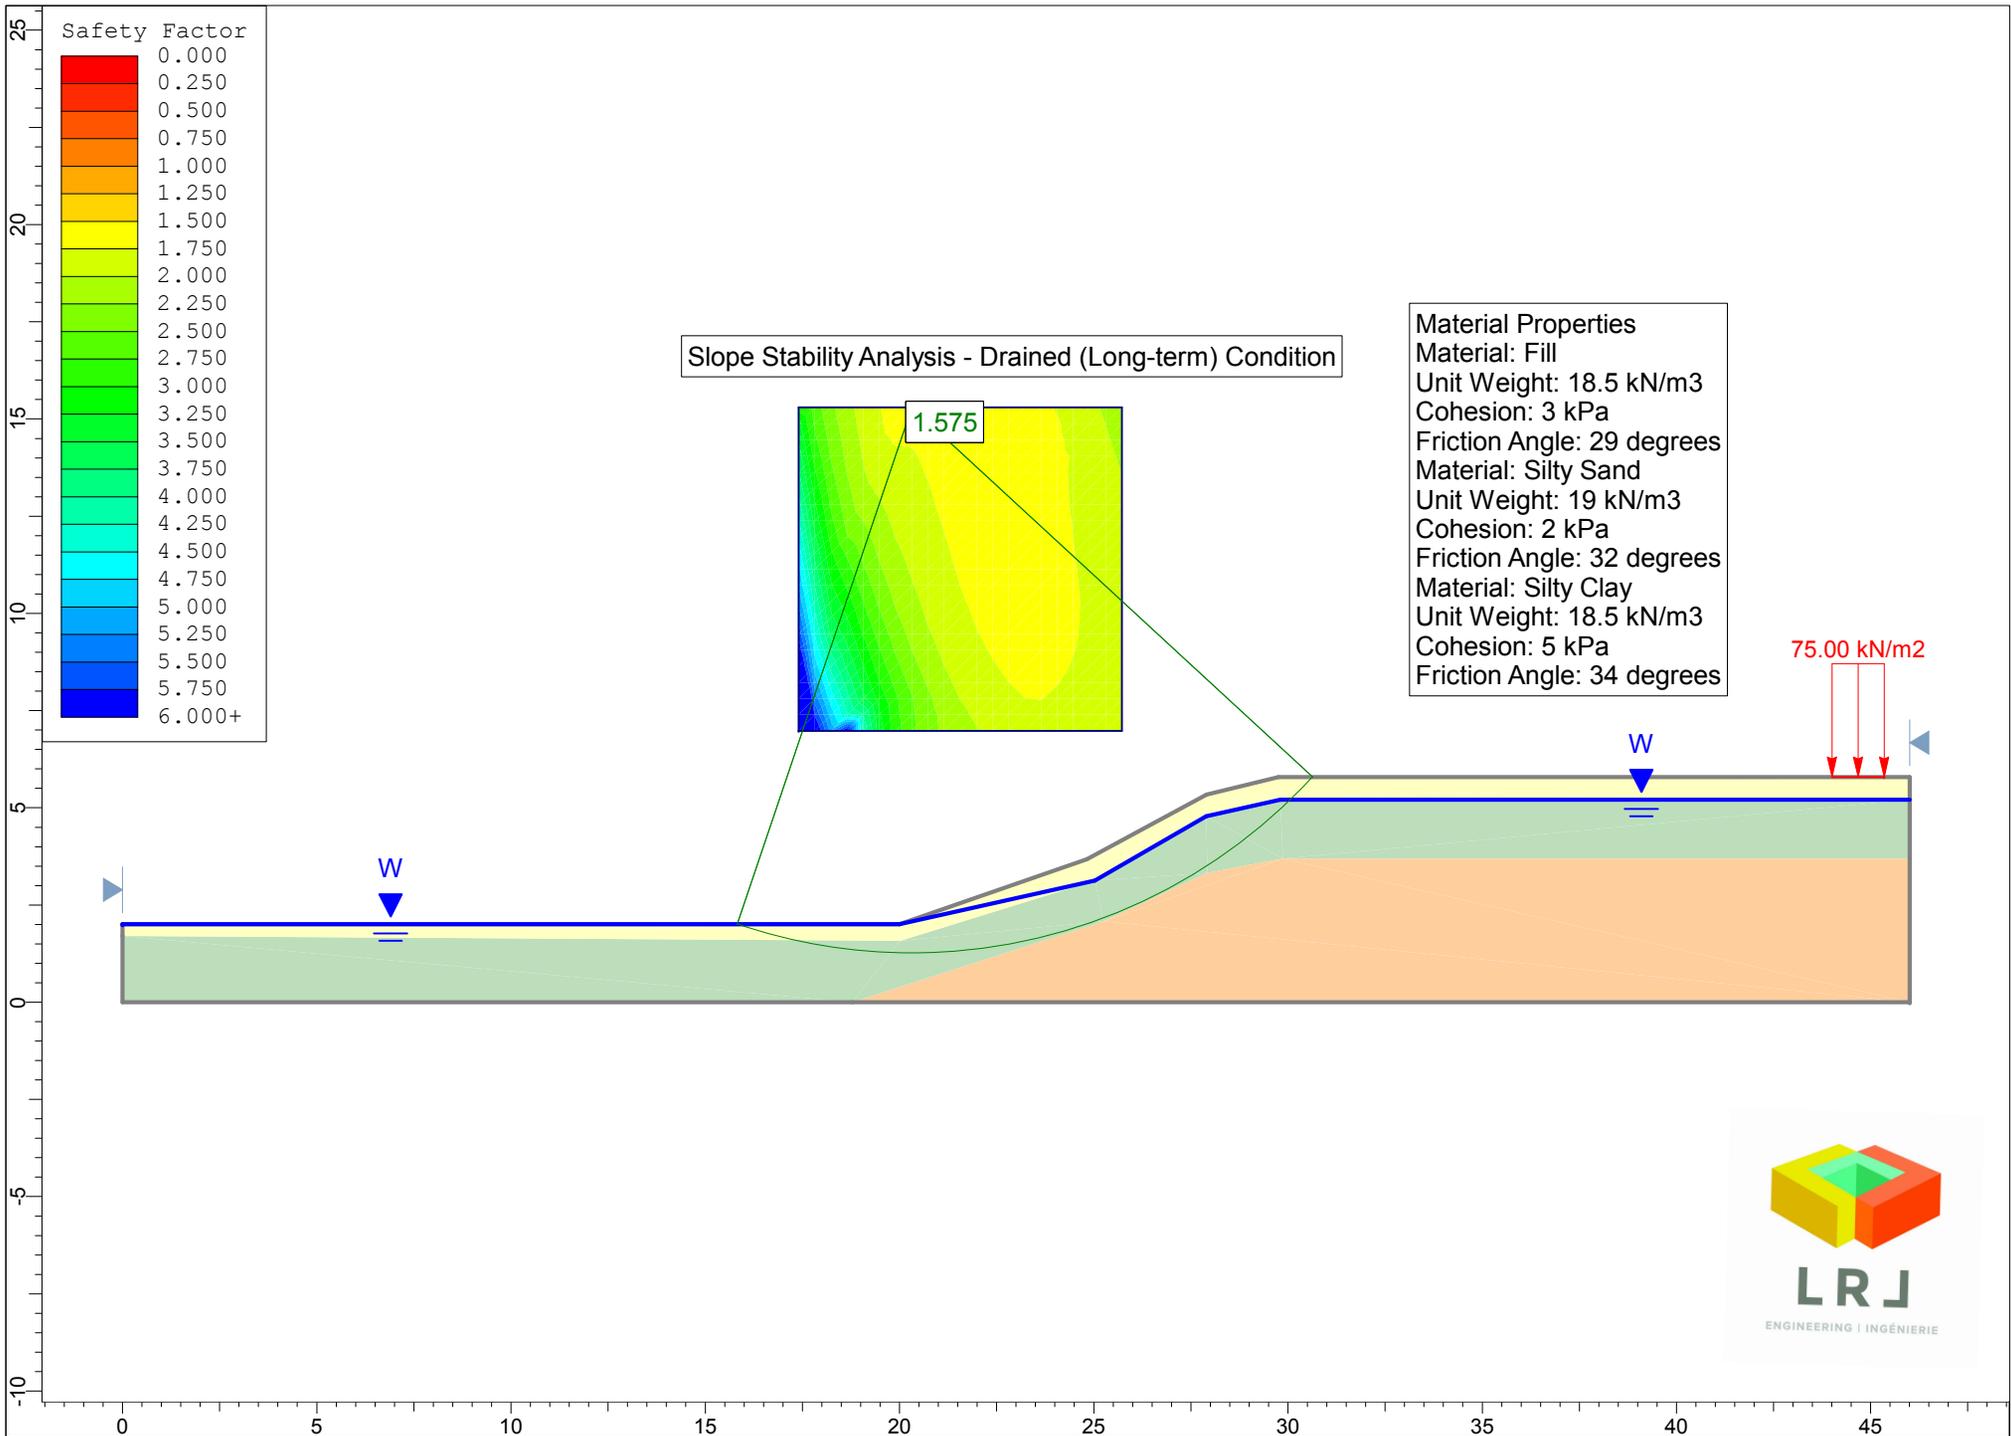
Encl. Slope Stability Analysis Results

The slope modelling program, Slide 5.0 (Rocscience), was used to implement the Bishop simplified method of slices. The slope profile for the existing slope conditions, as measured in the field was used and modeled to check the existing condition of the slope. The slope was analyzed under both the undrained and drained conditions (i.e. short and long term).

The model was ran with the designed house load for the undrained and drained condition. The factor of safety (FoS) values obtained were 2.09 and 1.58 respectively. A FoS of 1.5 or greater is considered to be safe with regard to slope stability. The designed house load was not provided (design bearing pressure at serviceability limit state) during our field investigation. However a typical value assumed to be 75 kPa for similar type of residential construction was included within the model.
